2013 MARUTI SUZUKI ALTO K10
VXI (O)
KOLKATA

Vehicle Rating And Pricing

PHYSICAL VERIFICATION OF REPOSSESSED VEHICLE

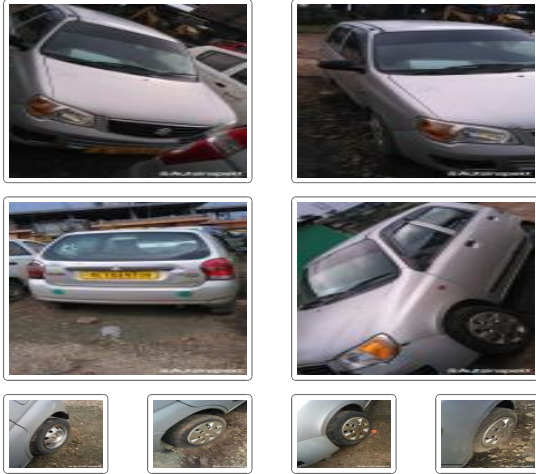
EXTERIORS

FRONT - BONNET	Average	6/10
BUMPER FRONT	Bad	2/10
HEAD LAMPS	Bad	4/10
RH SIDE - FENDER,DOORS	Bad	4/10
REAR	Bad	4/10
BUMPER REAR - BONNET	Bad	2/10
TAIL LAMPS	Bad	2/10
LH SIDE - FENDER , DOORS	Average	6/10
WINDSHIELD & GLASS (ORIGINAL)	Average	6/10
PAINT (REPAINTED)	Bad	4/10
NUMBER OF TYRES		4 TYRES
REMAINING AVERAGE TYRE LIFE		25%
SUNROOF / MOONROOF		NA

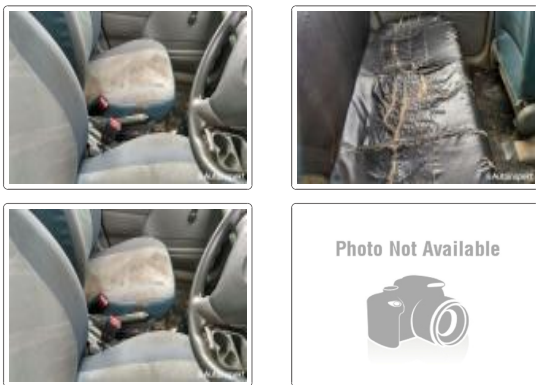
INTERIORS

STEERING	Bad	4/10
DASHBOARD	Bad	4/10
INTERIOR TRIMS	NA	
SEATS		4 Seats
SEATS CONDITION	Bad	2/10
SEAT UPHOLSTERY		NA
ACCESSORIES (AUDIO,COVERS)	Bad	4/10
