Mahindra First Choice Wheels Certification Report

2019 HYUNDAI VENUE(2019-2020) SX 1.4 (O) CRDI

East Champaran | 32644 km | Diesel | Manual | Blue Colour | 1st Owner

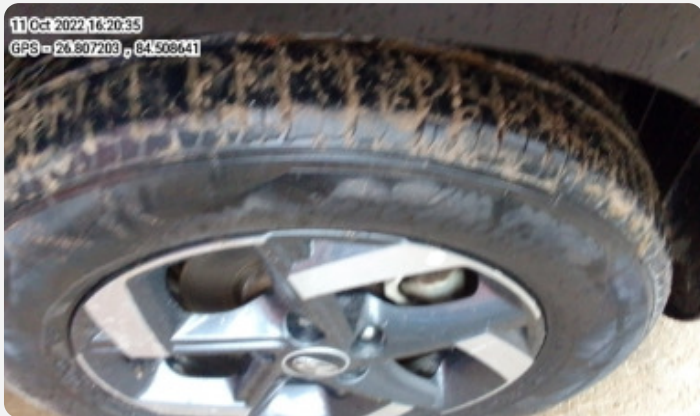
Front Right Tyre

Same Make/ Good & > 80% life

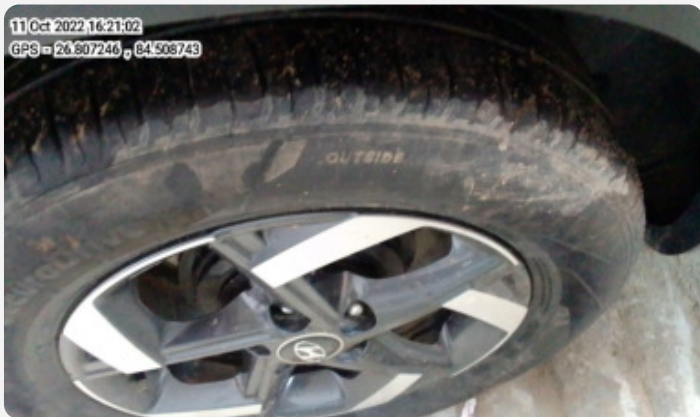
Rear Right Tyre

Same Make/ Good & > 80% life

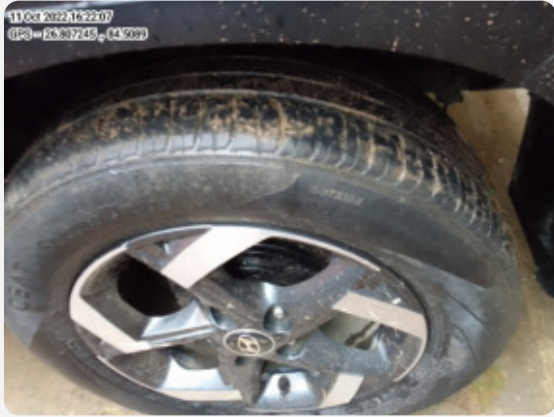
Rear Left Tyre

Same Make/ Good & > 80% life

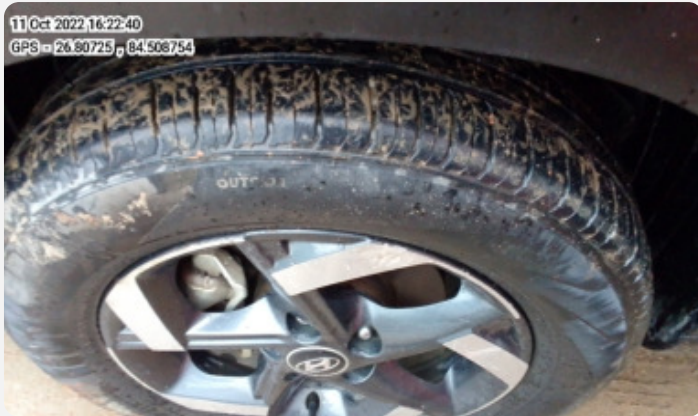
Front Left Tyre

Same Make/ Good & > 80% life

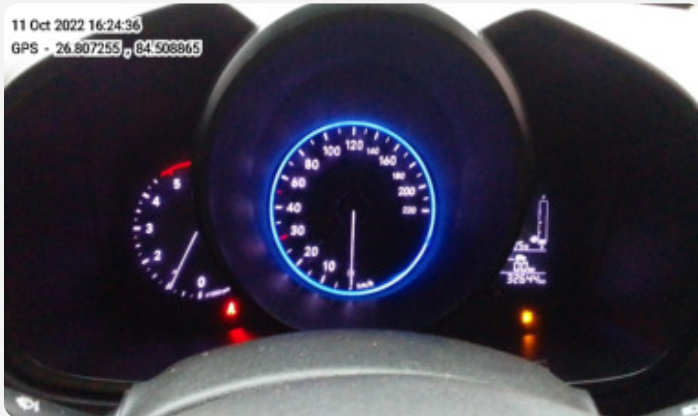
Odometer

32644
