Mahindra First Choice Wheels Certification Report

2021 RENAULT TRIBER RXZ BS-VI

Mumbai | 8863 km | Petrol | Manual | Silver Colour | 1st Owner

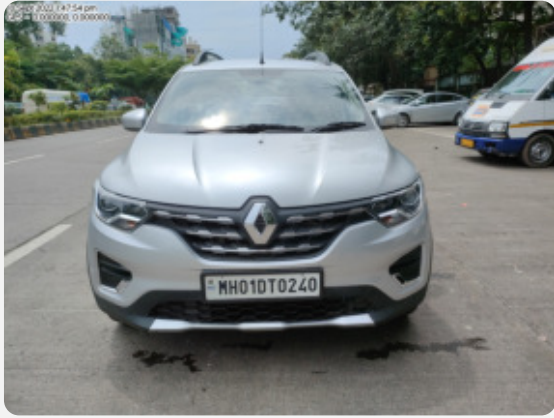
Front Side

Condition : Excellent

No damage

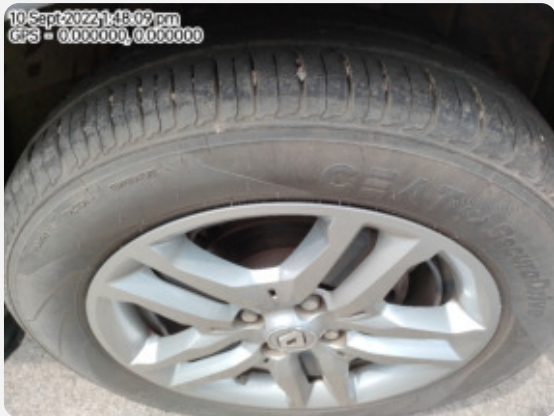
Front Right Tyre

Condition : Good

Same Make/ Good & > 60% life

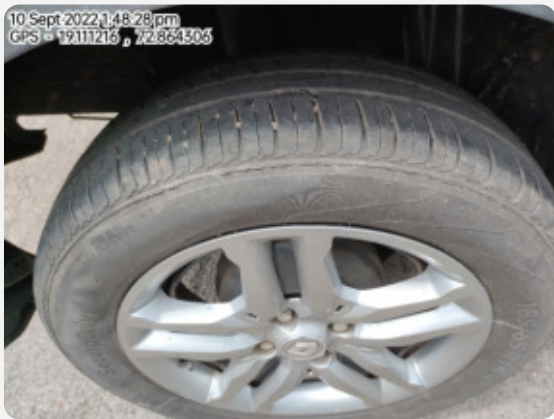
Rear Right Tyre

Condition : Good

Same Make/ Good & > 60% life

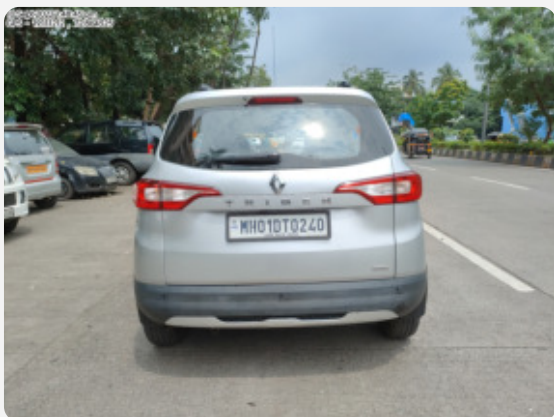
Back Side

Condition : **Excellent**

No damage

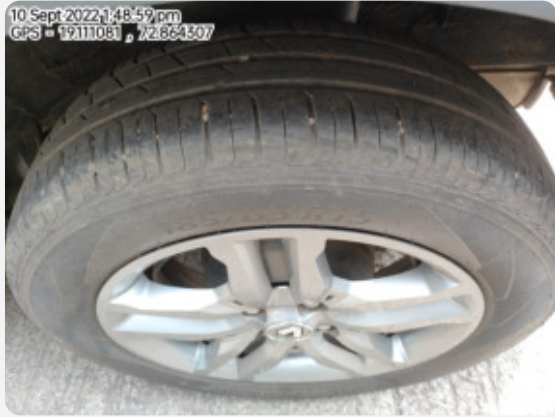
Rear Left Tyre

Condition : **Good**

Same Make/ Good & > 60% life

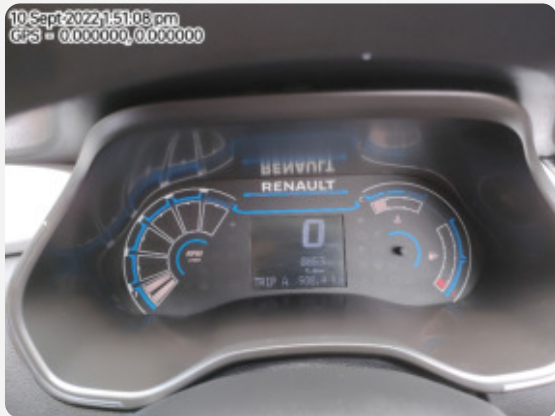
Odometer

8863
