## Mahindra First Choice Wheels Certification Report

**2019 MARUTI SUZUKI ERTIGA(2018-2022) ZXI PLUS BS-VI**

North Delhi | 40811 km | Petrol | Manual | White Colour | 1st Owner

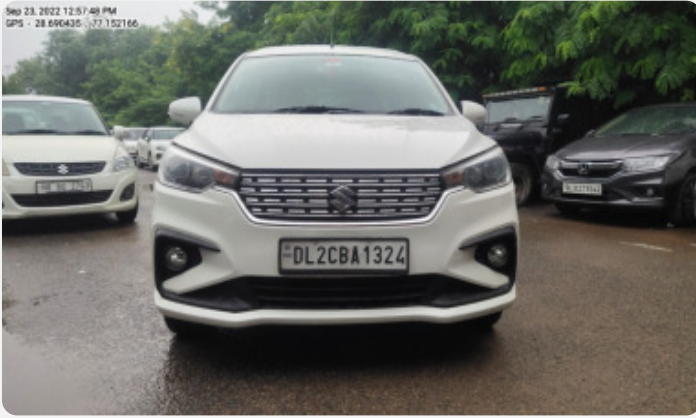
### Front Side

Condition : Good

Clean & slight color difference

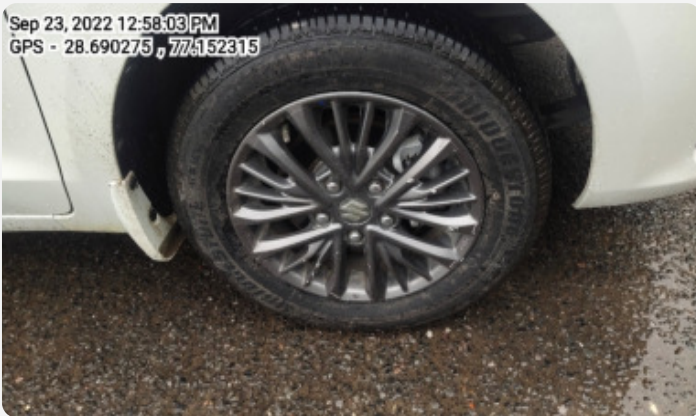
### Front Right Tyre

Condition : Satisfactory

Same Make/ Good & > 40% life

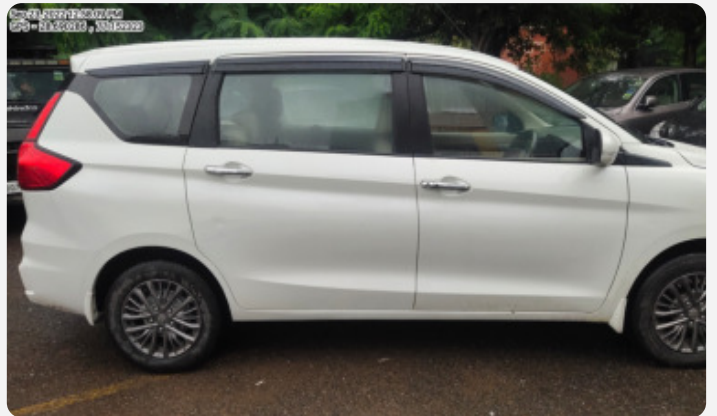
### Right Side

Condition : Good

1-2 minor dents & minimal scratches

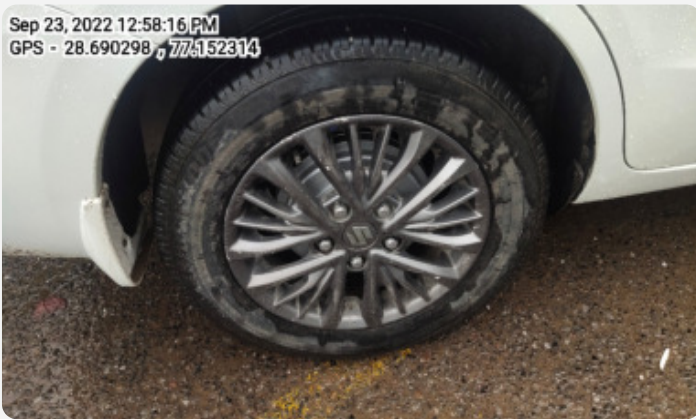
### Rear Right Tyre

Condition : Satisfactory

Same Make/ Good & > 40% life

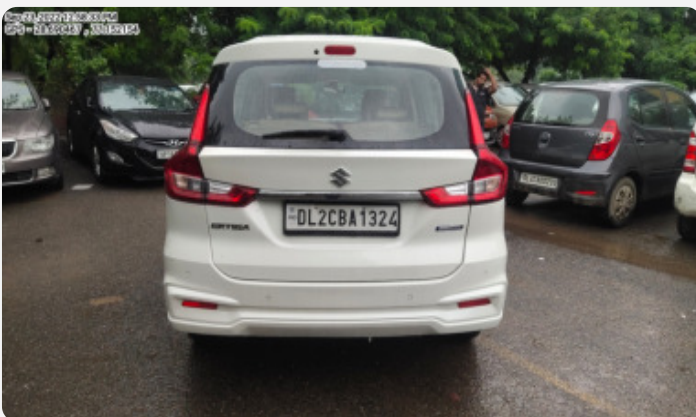
### Back Side

Condition : **Good**

Clean & slight color difference

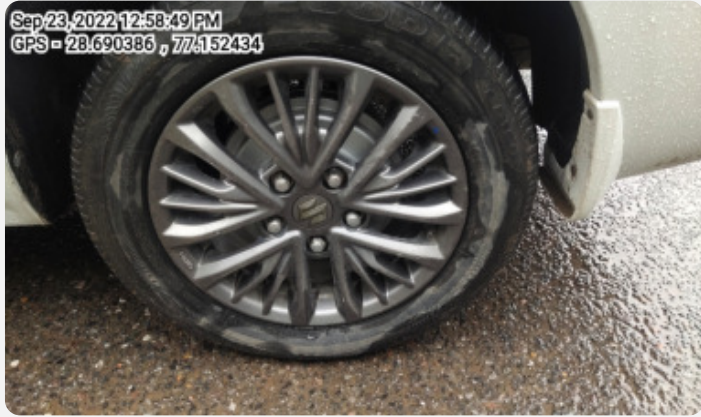
Rear Left Tyre

Condition : **Satisfactory**

Same Make/ Good & > 40% life

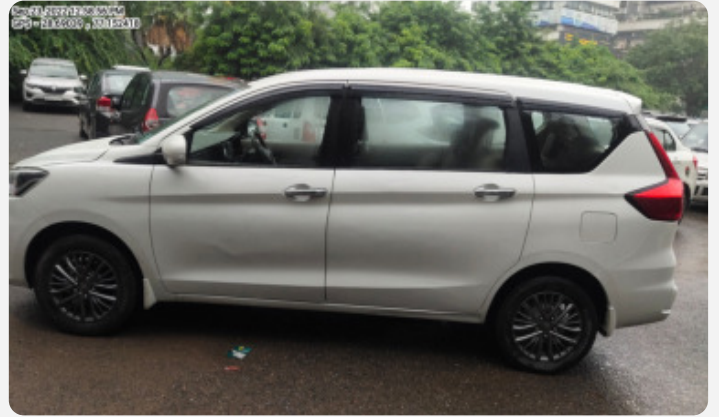
Left Side

Condition : **Satisfactory**

2-3 minor dents & minor scratches

Condition : **Good**

1-2 minor dents & minimal scratches

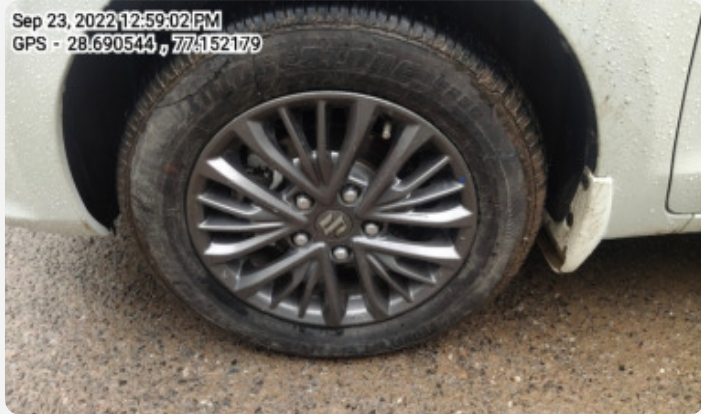
Front Left Tyre

Condition : **Satisfactory**

Same Make/ Good & > 40% life
