Mahindra First Choice Wheels Certification Report

2019 MARUTI SUZUKI VITARA BREZZA ZXI PLUS DUAL TONE

Gurgaon | 74129 km | Diesel | Manual | Red Colour | 1st Owner

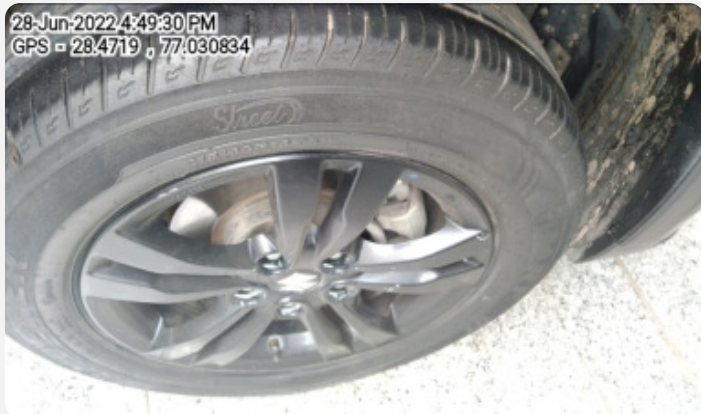
Front Right Tyre

Condition : Satisfactory

Same Make/ Good & > 40% life

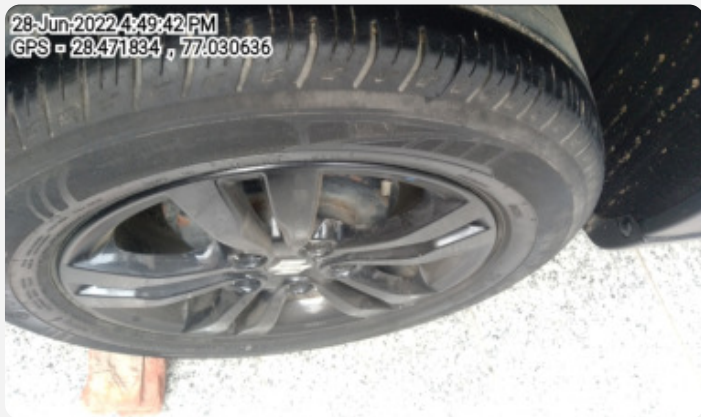
Rear Right Tyre

Condition : Satisfactory

Same Make/ Good & > 40% life

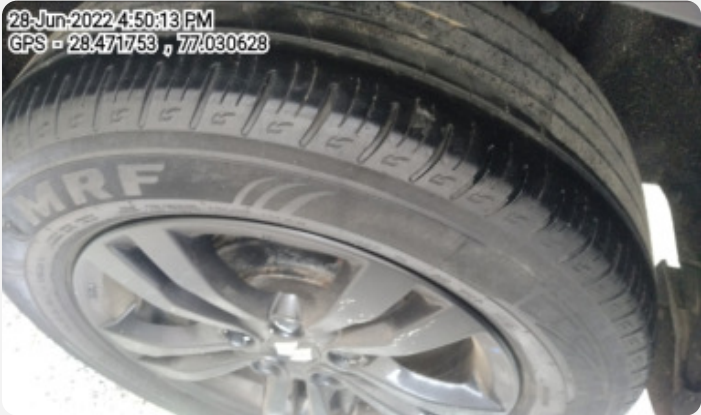
Rear Left Tyre

Condition : **Satisfactory**

Same Make/ Good & > 40% life

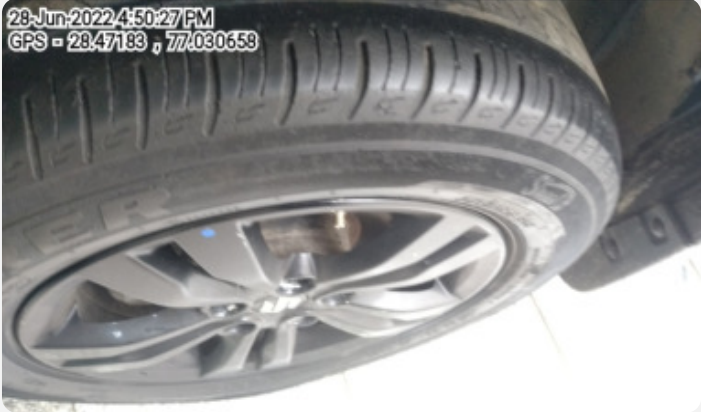
Front Left Tyre

Condition : **Satisfactory**

Same Make/ Good & > 40% life
