## Mahindra First Choice Wheels Certification Report

# 2016 RENAULT KWID(2015-2019) RXT

Thiruvananthapuram | 38919 km | Petrol | Manual | Grey Colour | 1st Owner

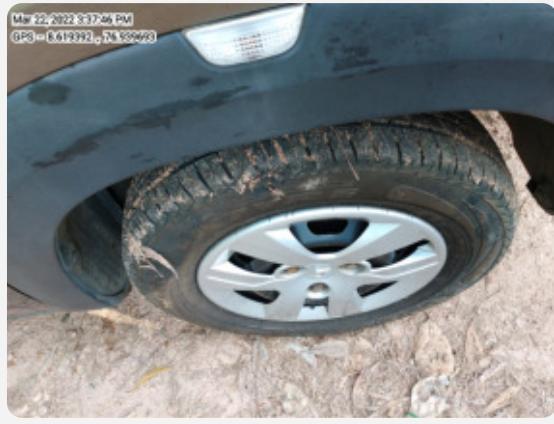
# Front Right Tyre

**Front Right Tyre Condition : Satisfactory** Same Make/ Good & > 40% life **Rear Right Tyre Condition : Satisfactory** Same Make/ Good & > 40% life **Right Fender** Condition : Excellent No dents or scratches

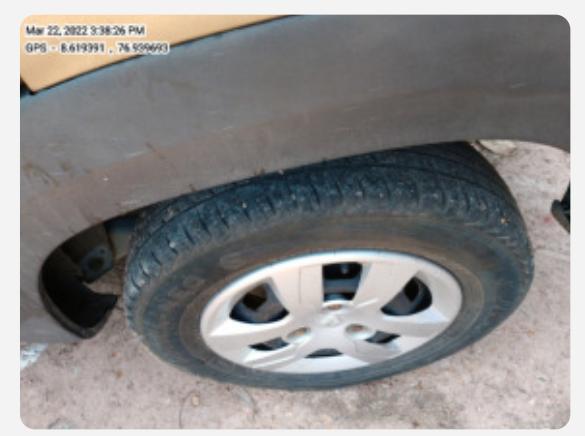
### Rear Left Tyre

**Rear Left Tyre Condition : Satisfactory** Same Make/ Good & > 40% life Frame or Underbody Condition : Excellent No panel changed

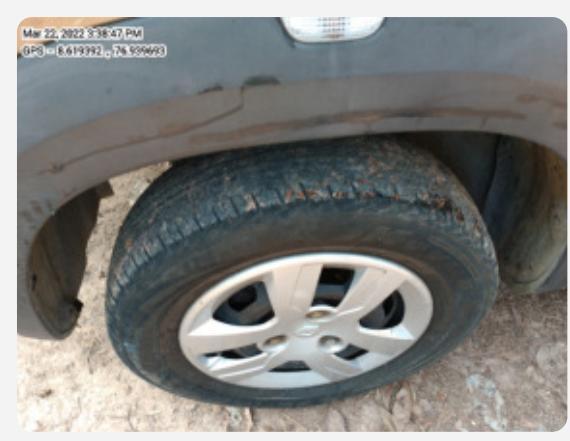
## Front Left Tyre

**Front Left Tyre**

**Condition : Satisfactory**

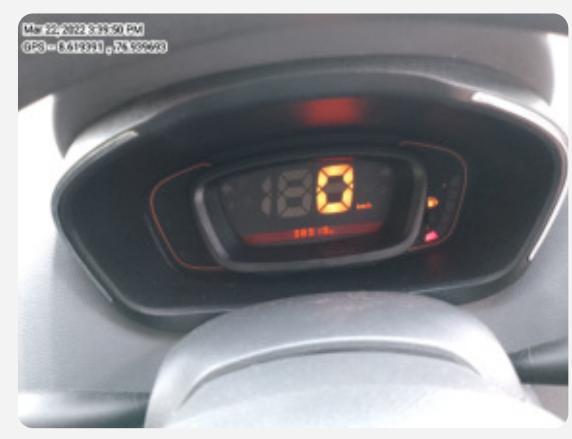
## Odometer

38919
