2013 MARUTI SUZUKI ALTO K10
VXI (O)
KOLKATA

Vehicle Rating And Pricing

PHYSICAL VERIFICATION OF REPOSSESSED VEHICLE

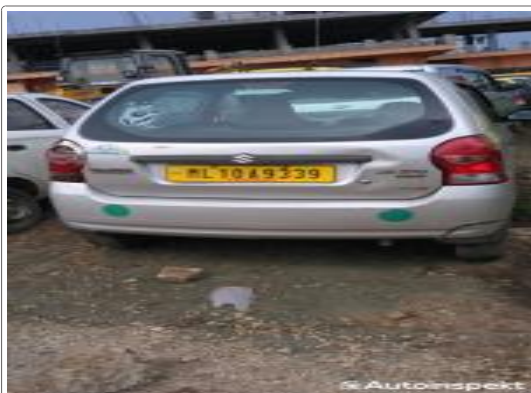
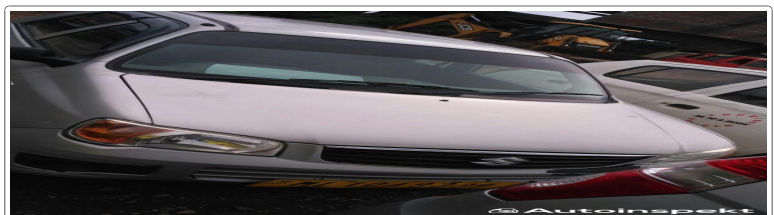
VEHICLE CONDITION & DOCUMENT DETAILS

Vehicle Condition	Running	Parking Location	Yard
Insurance Type	NA	RC Status	NO
Repo Date	13/08/2016
